Manhole Inspection Summary

Manhole # S29MM1013MH

Insp Date: **4/24/07 12:20 PM**

Location Address: **COLD SPRING LN**

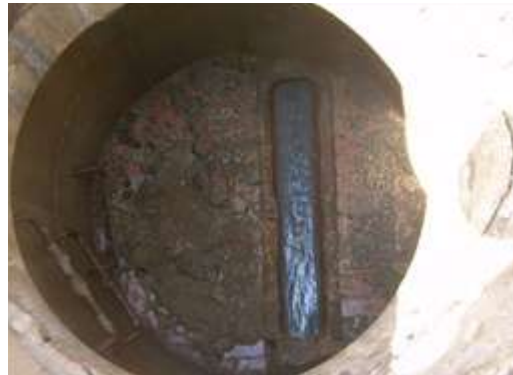
Top View

Evidence of surcharge - Bench debris

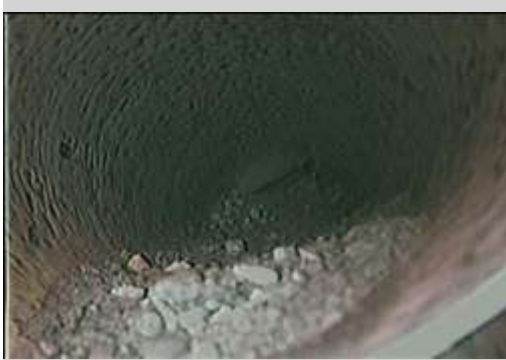
Inside the I10

Plugged.

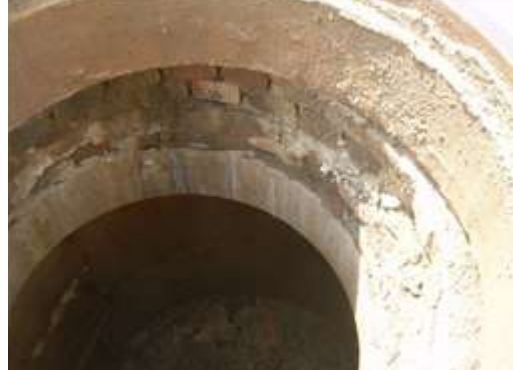
Defect

Frame Offset: **2** (in.) Condition: ☐ Sound ☐ Cracked ☒ **Leaks**

Condition: ☐ Sound ☐ Cracked ☐ Root Intrusion ☒ **Loose Brick** ☒ **Deteriorated**

Infiltration: ☐ None ☒ **Joint** ☐ Cracks ☒ **Mortar** ☐ Roots ☐ Wall

Frame leaks. Adjustment deterioration, loose brick and infiltration.

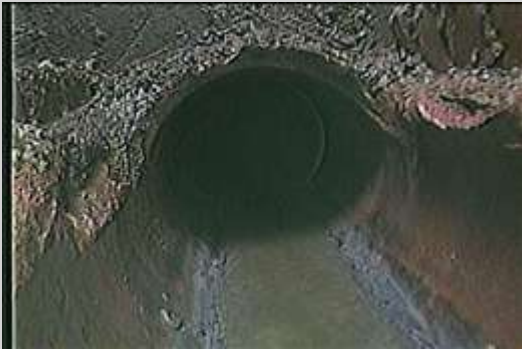
8 in. Circular Gravity Sewer Pipe Out @ 12 O'Clock

Invert Depth: **7.07** (ft.) Flow Characteristics: **Fast**

Infiltration: **None** Pipe Seal Cond: **Unknown**

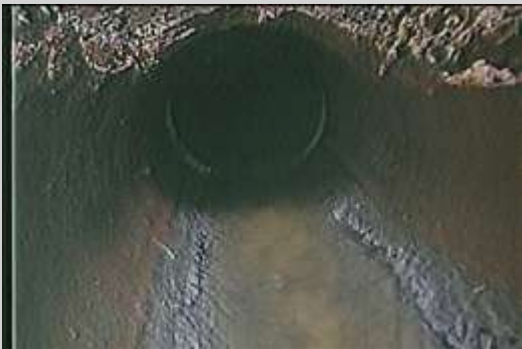
8 in. Circular Gravity Sewer Pipe In @ 6 O'Clock

Invert Depth: **6.80** (ft.) Flow Characteristics: **Fast**

Infiltration: **None** Pipe Seal Cond: **Unknown**

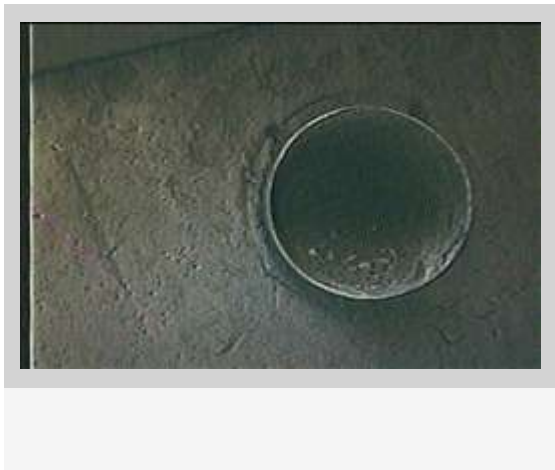
Pipe In @ 10 O'Clock

Connects To: **Stub connection / abandoned**
☐ Possible Illicit Connection
